Issued July 1978

METHODS AND FACILITIES FOR GRADING BROILERS AND TURKEYS

By Clarence E. Harris 1/

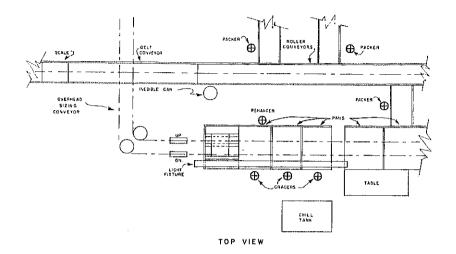
Figure 1.--Layout of broiler grading area in plant A.

Grading is primarily an in-line system in plant A. Figure 1 shows the layout of the grading area and arrangement of the equipment. The birds are suspended from nonrotating sizing shackles by one hock and are transported by a continuous overhead conveyor. It is normally operated at approximately 100 shackles passing the grading station per minute. As the birds pass before the graders, they are graded according to U.S. grade standards. The grade A product is allowed to remain on the conveyor, and undergrades are removed and placed in designated pans. Each shackle has an identification, such as a color code or tag, so that each of the three graders can select every third for grading. The identification is readily visible to avoid needless eye movement to the top of the shackle, since this can detract from the grading function.

The undesirable features of this grading area are as follows:

- The top of the pans restricts the graders' accessibility to the birds; they have to reach over the pans to get the birds.
- (2) The light fixture is too far in front of the graders so that the light shines in their eyes.
 - (3) The shorter employees require foot stands.

To alleviate the height problem for the short graders and to make the birds more accessible to others, the overhead conveyor could be raised 6 to 10 inches and a platform with a guardrail around it could be installed in the grading area. This platform should be wide and sturdy to insure safety and it could have adjustable legs so it could be raised or lowered to satisfy the graders' needs. Raising the overhead conveyor by 6 to 10 inches would bring the breast of the birds, suspended from the shackles, to the approximate eye level of graders. For women this is 58 inches from the floor (4).

Since the light fixture is too close horizontally to the overhead conveyor so that it shines into the eyes of the graders, it should be moved away from the overhead conveyor and raised to 6 feet 8 inches above the floor.

Another way to improve the grading operation is to provide more space between graders. In plant A, the pans for undergrade products are 30-1/2 inches apart and tend to limit the workspace for each grader to that width. With the shackles 6 inches on center and the overhead conveyor traveling at 100 shackles per minute past a given point, the grader has only 3 seconds per bird to perform his task when confined to 2-1/2 feet, whereas when the grader has 3 feet of space, he will have 3-3/5 seconds. Therefore, at least 3 feet of space should be provided for each grader. This can be accomplished by moving the table for wing tags and separating the three pans for undergrade birds to 6 inches or more or by using wider pans.

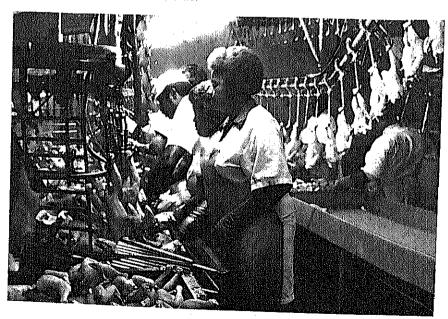
Figure 4.--Hanging birds at the drain rack.

In plant B, the birds are sorted as part of the function of transferring them from the chillers to the overhead conveyor (fig. 4). Those birds determined to be undergrades at the chiller drain rack are tossed onto a belt conveyor (fig. 5) located 3 feet from the drain rack and then hung on the overhead conveyor (cut-up line). The chiller drain rack area, where the birds are sorted, is well lighted by overhead fluorescent lamps covered with shields.

The sorting area is too congested. One way to alleviate this problem is to provide more drain rack space or frontage. This could be accomplished by moving the chillers farther apart and adding more rack in that area; however, moving the chillers probably would be costly, both in moving expense and wasted floorspace between the chillers. Another way to get more rack space would be to extend the rack at either end using deflectors or belt conveyors to move the birds out the ends. Complete separation of the two hanging areas, with separate slower moving overhead conveyors, would probably facilitate the highest degree of efficiency; however, this alteration also would be costly. In many other plants the sorting and hanging are performed from a belt conveyor moving in the same direction as the overhead conveyor. Usually the birds slide onto the moving belt conveyor as they come out of the chiller, moving along the conveyor until they are on the overhead conveyor shackles or dropping into a chill tank at the end of the belt. This might be more efficient than the present system.

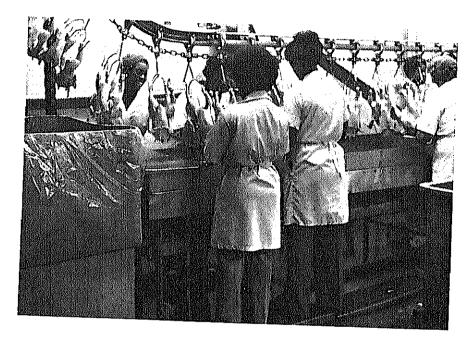
Figure 6.--Grading by authorized graders.

Grading is performed on an overhead conveyor by two authorized graders (fig. 6). Undergrade birds removed from the conveyor at the point just before the giblet stuffing operation are dropped into a pallet bin, where, after accumulation, they are transported to another area of the plant and hung on an overhead conveyor for the cut-up operation.

- (1) The grader has difficulty seeing the back of the birds, because they are suspended from the overhead conveyor by nonrotating shackles.
 - (2) Undergrade birds are not easy to remove from the shackles.
- (3) One of the grading positions has inadequate space for grading and not enough room adjacent to it for reconditioning the product.
 - (4) Each grading position is only 24 inches wide.
- (5) Since the floor is not well drained at the grading area, the graders stand on platforms, where their eye level is at about the height of the shackle rather than the bird.
 - (6) The grading area is not well lighted.
- (7) Birds accumulate to an excessive depth in the drain rack at the sorting area and contribute to the inefficiency of sorting and hanging the birds and increasing the probability of some of them being left in the rack for extensive periods.

The grading operation in plant B could be improved by increasing the width of the grading stations and improving the floor drainage in the area or raising the height of the shackles at the grading stations. The taller graders have difficulty seeing the lower half of the birds, and If the floor were well drained, these graders could stand on the floor rather than on the platforms. Also, fluorescent or other approved lamps should be installed on each side of the grading line (fig. 3) at a height of 6 feet 8 inches and about 3 feet from the overhead conveyor, and they should provide at least 50 foot-candles of light (3).

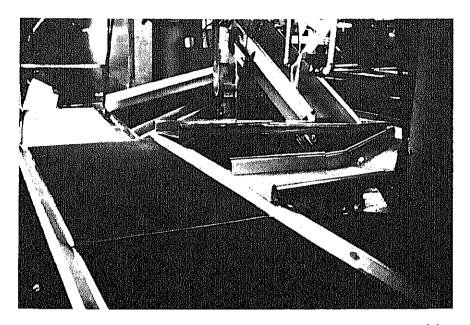
PN-6243
Figure 9.--Belt conveyor for grading birds as they pass from the chiller to the white belt (background).

- (1) The grading area has inadequate space for maneuvering from front to back of the workplace, and accessibility is restrictive, particularly for two of the grading positions.

- (5) Safety and noise levels at the grading area could be a problem. A belt conveyor operating about 5 to 6 feet above the floor and behind one of the graders could be a safety hazard. The grader has to go under a chute while stepping over another belt conveyor in order to get to and from the grading position. This is inconvenient and unsafe. Noise at the grading area is relatively high because numerous machines are operating close to the graders.

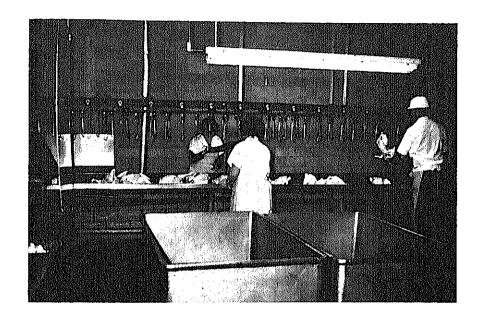
PN-6246 Figure 14.~-Grading area with chill tanks for undergrade birds (foreground).

- (1) The grading belt, which is 33 inches above the floor, is too low for most graders, especially with the higher edge of the shelves, which are 37 inches above the floor.
- (2) J hooks moving past the grading area at 4 feet 8 inches above the floor could be hazardous because they are close to eye level.
